ARE YOU REALLY GETTING WHAT YOU EXPECT FROM YOUR CALIPER SUPPLIER?

Fraser Gauge and Tool Company

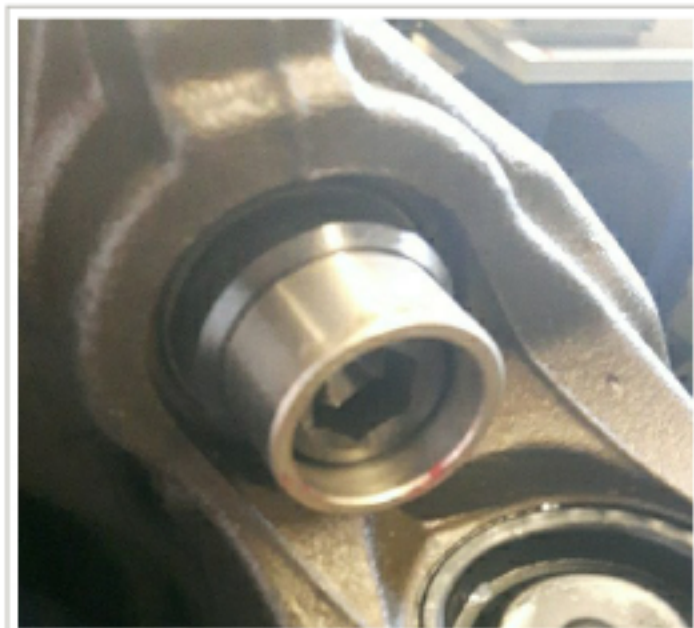
This Rubber/ Metal Bush is the old design revision that Knorr-Bremse replaced some time ago. Fraser Gauge upgrades the most recent.

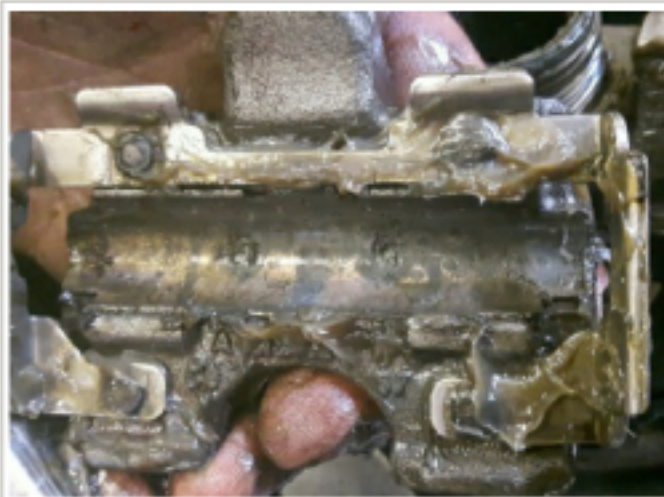
The Lever Bearing was re-used. This is a wearing part.

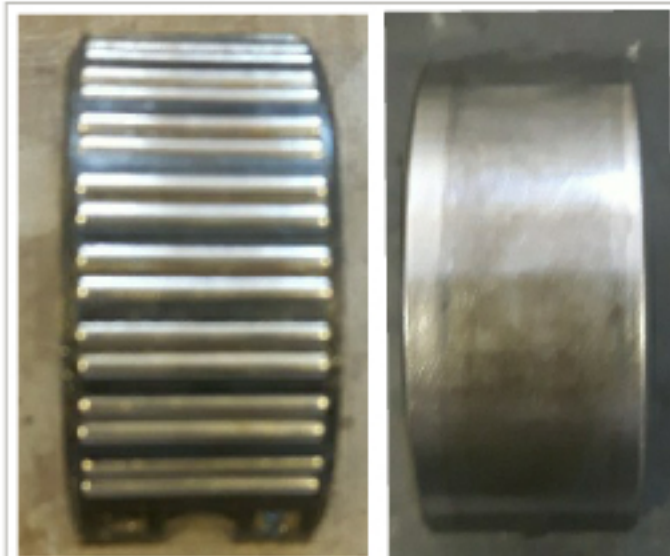
The Needle Rollers & Shells had been re-used. The Needle Rollers especially are a wearing part.

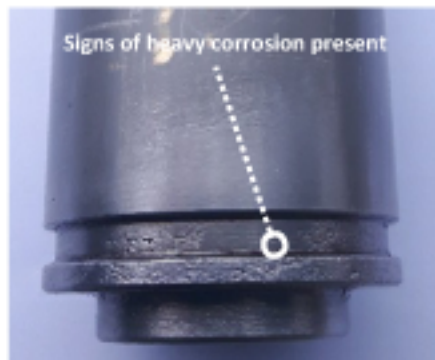
Evidence of previous use and score marks present where an attempt has been made to polish away.

The large Guide Pin Bush was an Original Knorr-Bremse Bushing had been re-used. An attempt had been made to "Polish" this Bush. This is a wearing Part. Fraser Gauge has always discarded the Old Bushings, and replaced with NEW. The Large Guide Pin was re-used. This is a wearing Part. Fraser Gauge have always supplied NEW Guide Pins.

You can check for re-used Guide Pins and Bushes yourself by simply removing the large Guide Pin from the Caliper bore and wiping away any grease surrounding it. If you can see wear marks, corrosion or other signs of damage similar to what can be seen in the pictures above then these parts have been re-used. If this corner has been cut then it is most likely that other wearing parts have also been re-used. Parts such as these are something that you should be getting brand new AS STANDARD when buying a REMANUFACTURED Disc Brake Caliper.
